**Flood Control Project Maintenance  
Levee Inspections**  
**LMA District Cover Sheet**  
**Spring 2011 Levee Inspection Results**

**Reclamation District No. 2101 Blewett**

**Levee Inspection Report By Mile - Spring 2011**

Waterway				Bank	Unit Miles	Inspection Start/End	Inspector
Unit No. 01 San Joaquin River				Left	3.20	05/26/2011 05/26/2011	Jim Eto

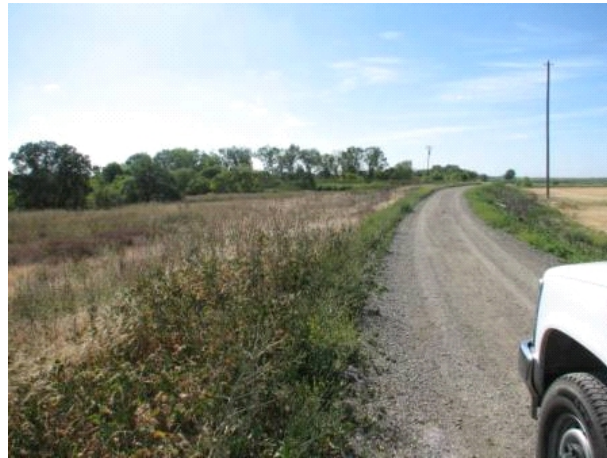
Levee Mile Report Line	2
Start Levee Mile	0.02
End Levee Mile	2.75
Location	Water Side
Category	Earthen Levee
Item	Vegetation
05/26/2011 Vegetation growth is typical for waterside slopes for the entire length of the unit. LMA has stated that DFG restrictions will not allow him to spray or perform proper vegetation control on the waterside of the levee.	
jeto_s_20110527_529.jpg

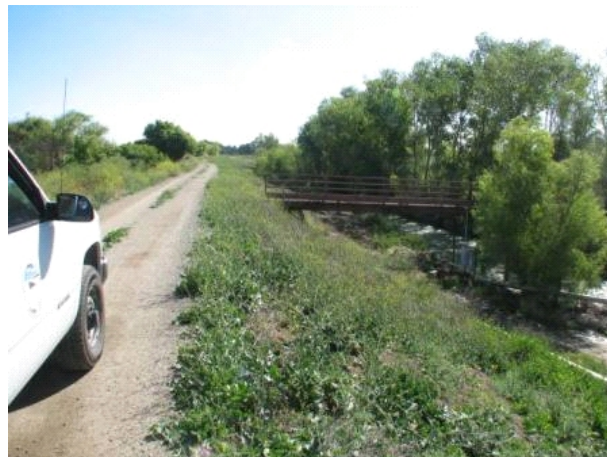
Levee Mile Report Line	3
Start Levee Mile	0.02
End Levee Mile	2.75
Location	Land Side
Category	Earthen Levee
Item	Vegetation
05/26/2011 Vegetation growth is typical of landside slope for the entire length of the unit.	
jeto_s_20110527_528.jpg

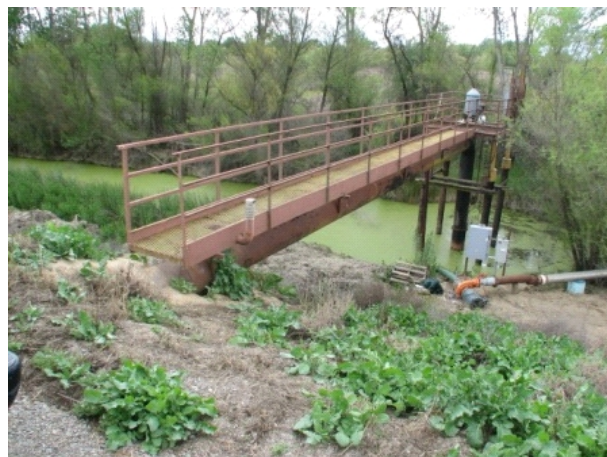
Levee Mile Report Line	6
Start Levee Mile	0.19
End Levee Mile	0.19
Location	Crown
Category	Earthen Levee
Item	Encroachments
Drainage discharge under levee crown.	
jeto_s_20110301_278.jpg

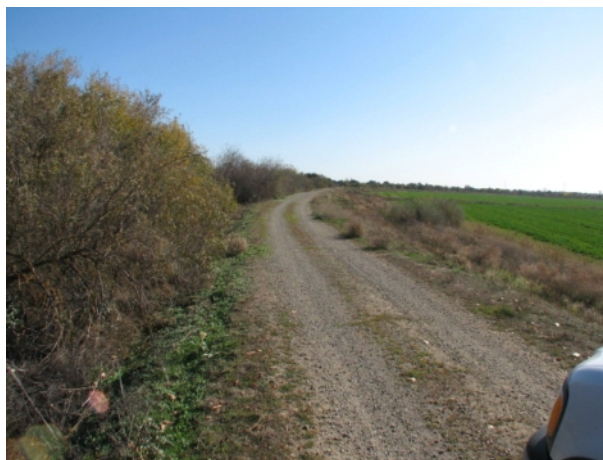
Levee Mile Report Line	8
Start Levee Mile	0.49
End Levee Mile	0.49
Location	Water Side
Category	Earthen Levee
Item	Trim / Thin Trees

Trees on top 20-ft of waterside slope block access and visibility.

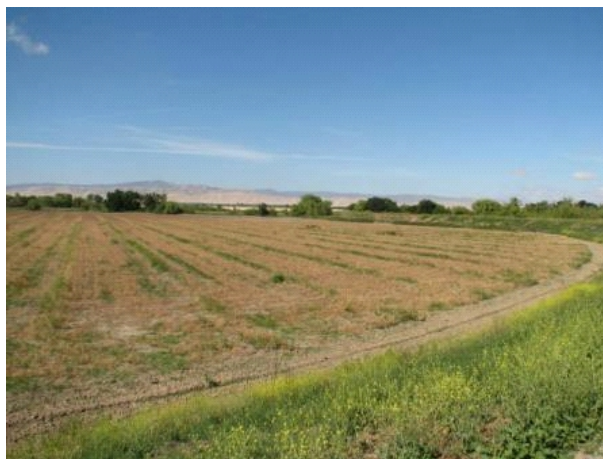
Levee Mile Report Line	9
Start Levee Mile	0.59
End Levee Mile	0.67
Location	Land Side
Category	Earthen Levee
Item	Seepage / Sandboils

9	0.59	0.67	Earthen Levee	Seepage / Sandboils	LS	U	Inspector Comments: 05/26/2011 Picture shows field damaged by water from seepage.	37.660029 ° -121.246400 °	37.659956 ° -121.244706 °	31 Y
10	0.73	0.73	Earthen Levee	Vegetation	WS	M	Remove the wild growth other than native grasses from the levee slopes. Inspector Comments: Wild Rose has been trimmed back some.	37.659856 ° -121.243806 °	37.659856 ° -121.243806 °	9
11	0.74	1.34	Earthen Levee	Vegetation	WS	C	Remove the wild growth other than native grasses from the levee slopes.	37.659805 ° -121.243678 °	37.653223 ° -121.238531 °	17

05/29/2011 Discolored field is a result of sitting water from through seepage. Seepage is through a previously repaired portion of the levee.

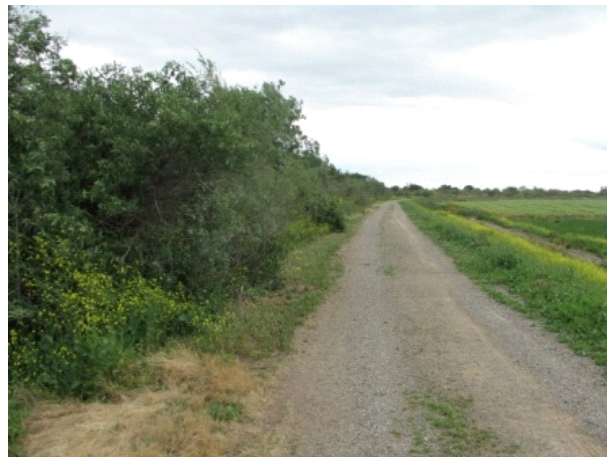
Levee Mile Report Line	21
Start Levee Mile	1.62
End Levee Mile	1.84
Location	Water Side
Category	Earthen Levee
Item	Trim / Thin Trees

21	1.62	1.84	Earthen Levee	Trim / Thin Trees	WS	M	Thin trees to allow visibility of the ground and room to flood fight.	37.651574 ° -121.234326 °	37.650748 ° -121.230342 °	26 Y
22	1.63	1.63	Earthen Levee	Encroachments	LS	PO	Poles	37.651555 ° -121.234061 °	37.651555 ° -121.234061 °	14
23	1.83	1.99	Earthen Levee	Encroachments	WS	C	Agricultural tilling Inspector Comments: Discing near levee slope within 10' of levee toe.	37.649811 ° -121.228047 °	37.649811 ° -121.228047 °	16
24	1.85	2.61	Earthen Levee	Vegetation	WS	C	Remove the wild growth other than native grasses from the levee slopes.	37.651508 ° -121.234595 °	37.643625 ° -121.229221 °	22
25	1.91	2.00	Supplemental	DWR Erosion Survey	WS	U	Inspector Comments: 05/26/2011 Damaged area now encroaches into the levee prism, Photo has been provided by LMA, photo taken during high water. Thick thistle growth prevented access to take current picture on day of inspection.	37.650259 ° -121.228961 °	37.650259 ° -121.228961 °	1 Y

Trees on top 20' of waterside slope obstruct access and visibility.

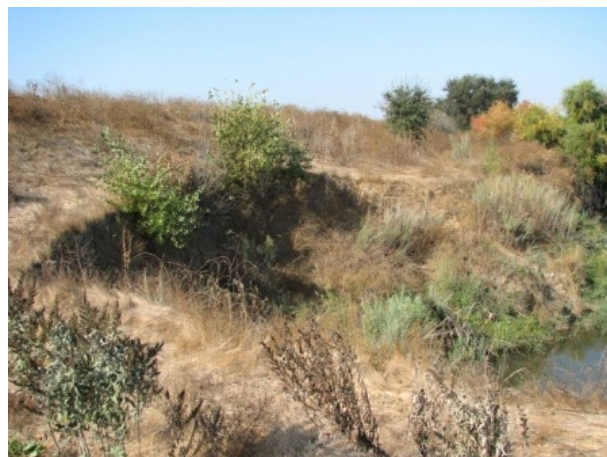
Levee Mile Report Line	25
Start Levee Mile	1.91
End Levee Mile	2.00
Location	Water Side
Category	Supplemental
Item	DWR Erosion Survey

Looking downstream at a section of the erosion site where scouring caused by an eddy has occurred.

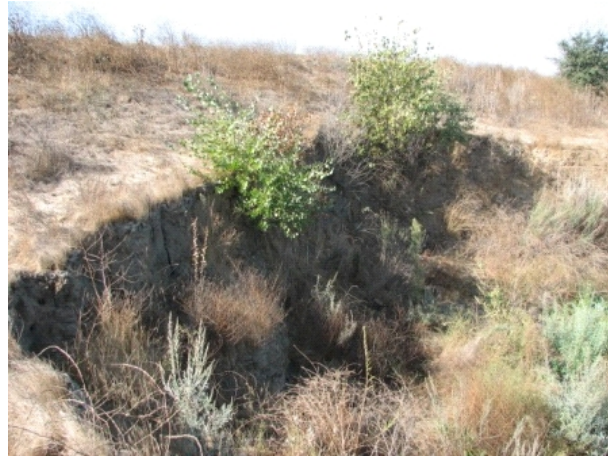
Levee Mile Report Line	25
Start Levee Mile	1.91
End Levee Mile	2.00
Location	Water Side
Category	Supplemental
Item	DWR Erosion Survey

Looking downstream at the 100-ft long scour.

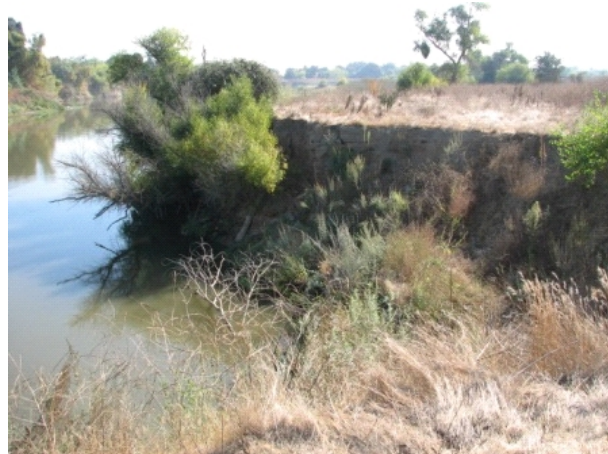
Levee Mile Report Line	25
Start Levee Mile	1.91
End Levee Mile	2.00
Location	Water Side
Category	Supplemental
Item	DWR Erosion Survey

Looking upstream at the scour site.

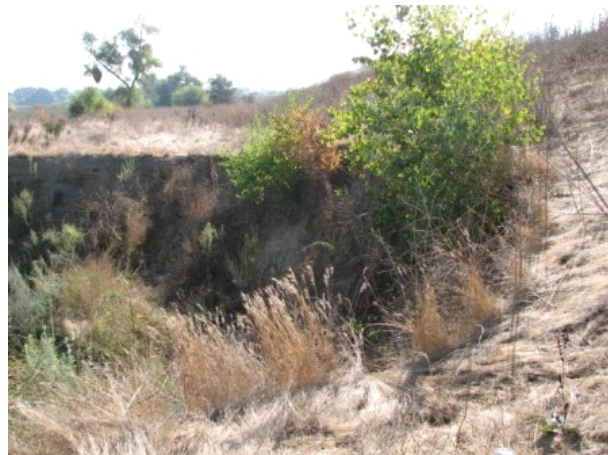
Levee Mile Report Line	25
Start Levee Mile	1.91
End Levee Mile	2.00
Location	Water Side
Category	Supplemental
Item	DWR Erosion Survey

Looking upstream at the scour site.

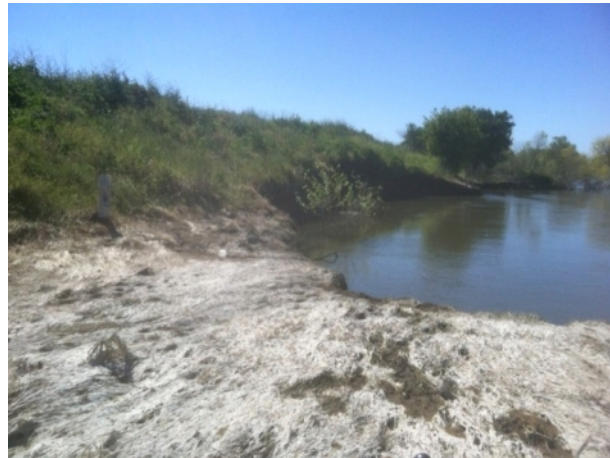
Levee Mile Report Line	25
Start Levee Mile	1.91
End Levee Mile	2.00
Location	Water Side
Category	Supplemental
Item	DWR Erosion Survey

Updated photo provided by LMA. Looking downstream at scour area. Note that bushes in photo from 12/16/2010 are now gone.

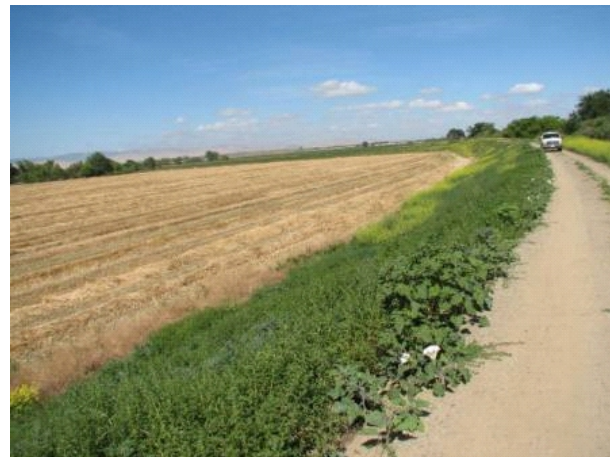
Levee Mile Report Line	26
Start Levee Mile	1.91
End Levee Mile	2.00
Location	Land Side
Category	Earthen Levee
Item	Seepage / Sandboils

26	1.91	2.00	Earthen Levee	Seepage / Sandboils	LS	U	Inspector Comments: 05/26/2011 LMA reports that seepage was occurring through Erosion survey site, causing damage to adjacent field.	37.650259 ° -121.228961 °	37.650259 ° -121.228961 °	8 Y

05/26/2011 Field which had crop damage due to sitting water from seepage through erosion control site.

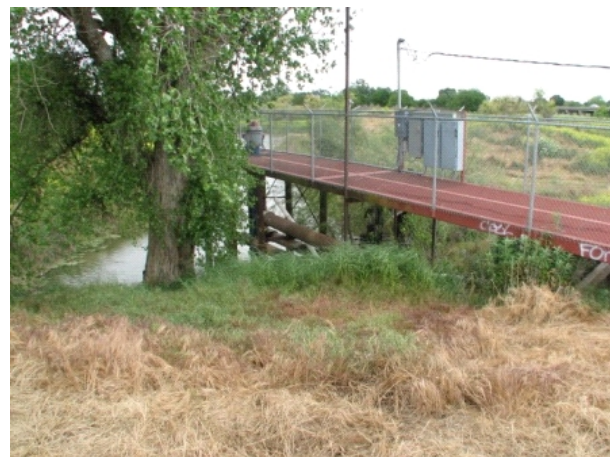
Levee Mile Report Line	31
Start Levee Mile	2.74
End Levee Mile	2.74
Location	Water Side
Category	Earthen Levee
Item	Encroachments

Irrigation intake near Maze Blvd.

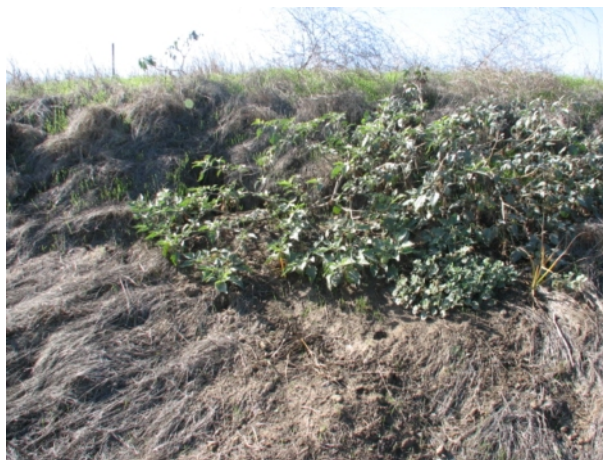
Levee Mile Report Line	33
Start Levee Mile	2.88
End Levee Mile	2.88
Location	Water Side
Category	Earthen Levee
Item	Animal Control

Rodent holes on levee slope hidden by vegetation.

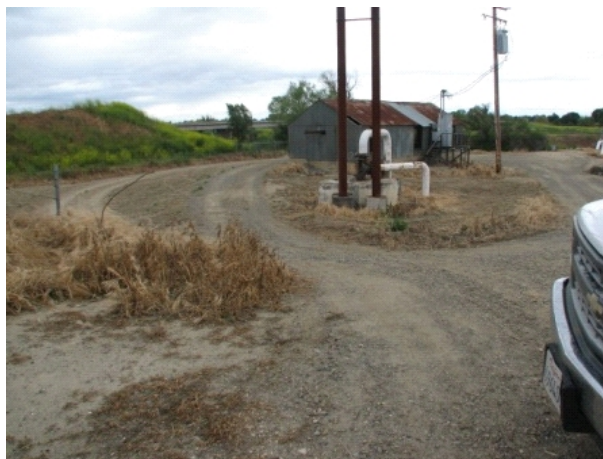
Levee Mile Report Line	34
Start Levee Mile	2.89
End Levee Mile	2.89
Location	Water Side
Category	Earthen Levee
Item	Encroachments

Risers on waterside berm and risers along road leading to levee indicate presence of pipe penetration.

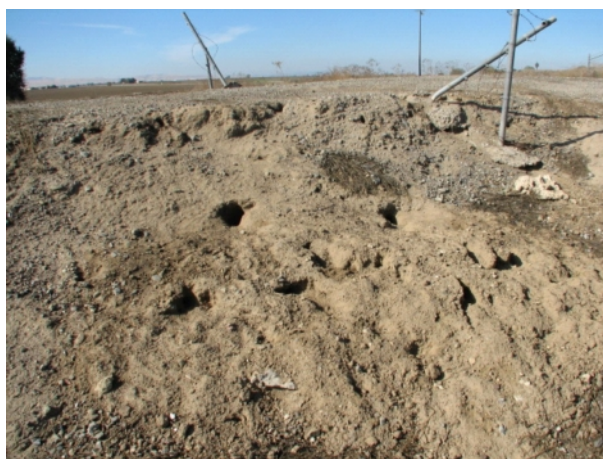
Levee Mile Report Line	35
Start Levee Mile	2.89
End Levee Mile	2.89
Location	Land Side
Category	Earthen Levee
Item	Animal Control

Rodent holes on levee slope.

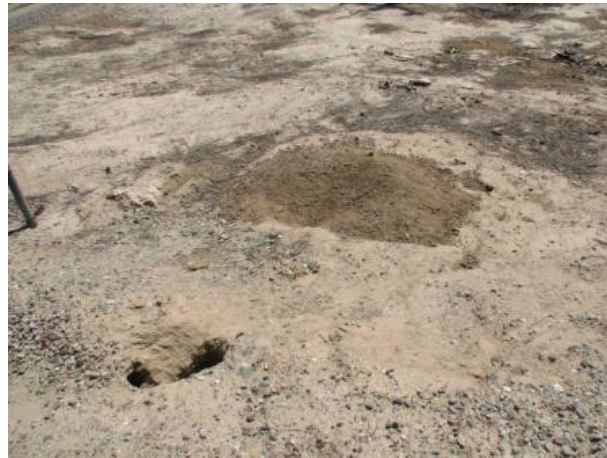
Levee Mile Report Line	35
Start Levee Mile	2.89
End Levee Mile	2.89
Location	Land Side
Category	Earthen Levee
Item	Animal Control

05/26/2011 Updated photo of animal control issue noted in Fall 2010 inspection, fresh rodent burrow present.

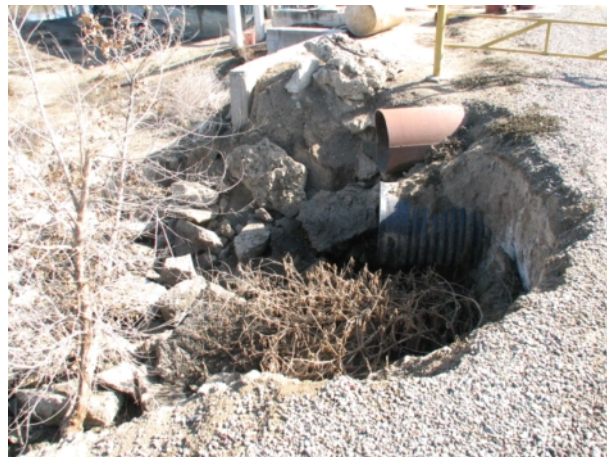
Levee Mile Report Line	36
Start Levee Mile	2.91
End Levee Mile	2.91
Location	Water Side
Category	Earthen Levee
Item	Erosion / Bank Caving

Levee slope is being eroded at this location. Repair needed to preserve access road.

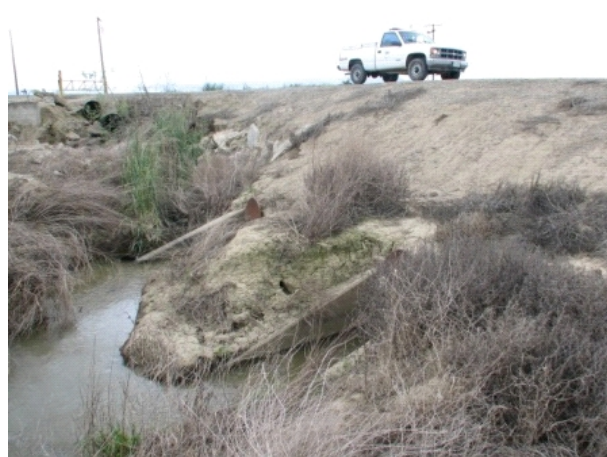
Levee Mile Report Line	37
Start Levee Mile	2.91
End Levee Mile	2.91
Location	Water Side
Category	Earthen Levee
Item	Encroachments

Drainage discharge to San Joaquin River.

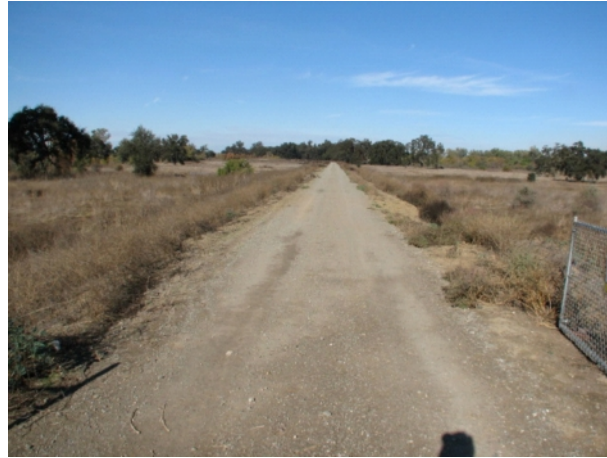
Levee Mile Report Line	1
Start Levee Mile	0.00
End Levee Mile	0.30
Location	Water Side
Category	Earthen Levee
Item	Vegetation

Tall weeds on levee slope obstruct visibility.

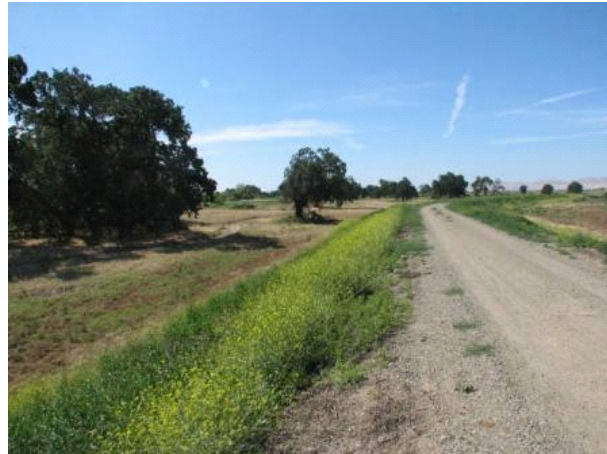
Levee Mile Report Line	1
Start Levee Mile	0.00
End Levee Mile	0.30
Location	Water Side
Category	Earthen Levee
Item	Vegetation

05/26/2011 Photo shows typical vegetation for the entire length of the spur levee.

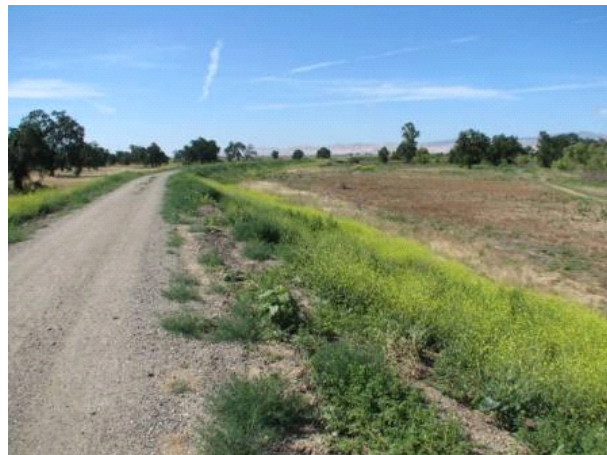
Levee Mile Report Line	2
Start Levee Mile	0.00
End Levee Mile	0.30
Location	Land Side
Category	Earthen Levee
Item	Vegetation

05/26/2011 Photo shows typical vegetation for the entire length of the spur levee.
